**UCLA Rocket Project**  
Vehicle: Prometheus (Hybrid) | Cycle: 25-26

**Test Summary Report**  
**Static Fire Campaign #2**

**Document No.:** PROM-HFIRE-002-26101  
**Revision:** A  
**Release Date:** 2026-04-15

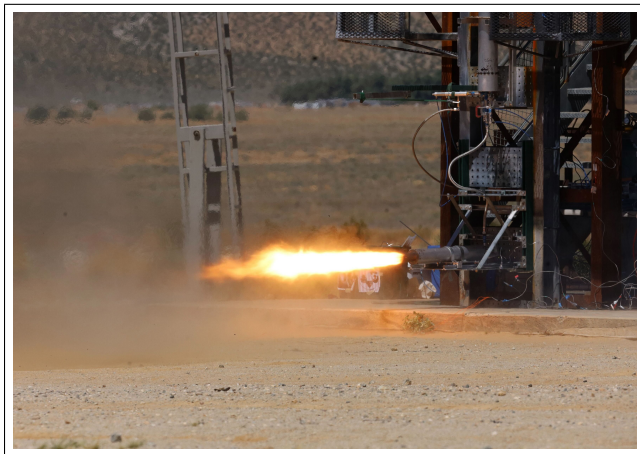
The first SRAD engine, “Amber,” performed nominally with no burn-throughs or large visual anomalies. The secondary engine, “Particularity,” was not fired due to fuel grain mold release issues. Setup began with preparing for high press at around 11 PM. The fill table was low-pressed early, but due to electronics issues, high press was not started until 7 am. High press failed twice due to leaking fittings, and passed with a narrow margin ( 9.4psi/min). We successfully filled and fired at around 12:25 PM. Due to a significantly lower tank pressure at ignition (600 psi vs. 750), we had a longer burn time (14s vs 12s) and lower peak thrust (521 lbf vs. 586 lbf). The engine exhaust plume jumped to 1ft in length around 1s, then stayed relatively constant. Mach diamonds were seen clearly around 2-5s into the burn. The engine experienced significant chugging in the latter half of the burn, which was observed visually (flickering exhaust plume) and heard as a deep rumble. The exhaust visually stabilized immediately at blow-down, which continued until T+00:25 s when large black plumes of smoke started coming out of the nozzle.

(a) Thrust plume

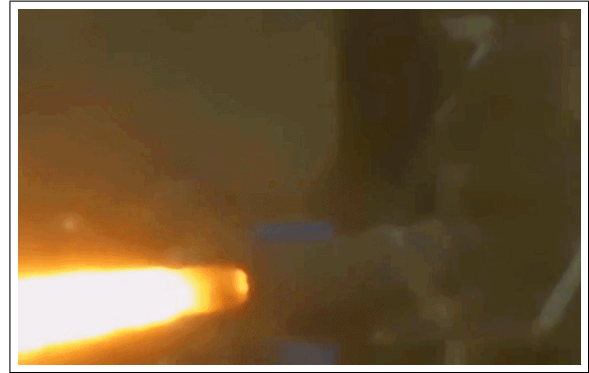
The load cell was not bolted to the structure's back plate, allowing the engine to lift within the clamps during the burn. The vertical displacement reduced the load cell readings, lessening the thrust measurement.

(b) Axial lift-off during steady-state burn

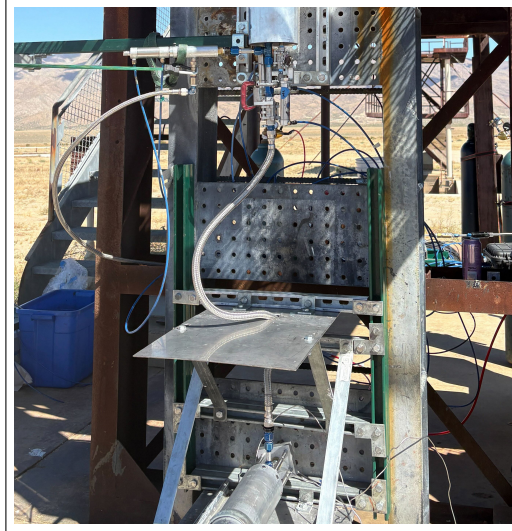
The flex hose from the MPV to the injector was run too long with sharp bends and loops, introducing pressure losses. Flex hose choice needs to be particular.

Figure 3: Non-optimal flex hose with excessive bends

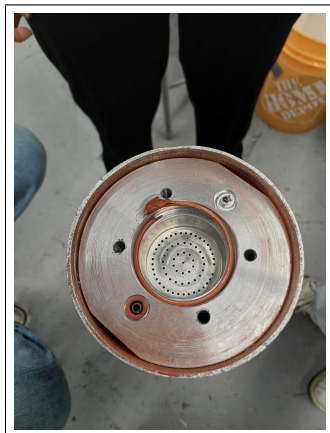
Figure 4: Manifold.

While the manifold o-ring was still sealed, it appears to have ruptured, possibly due to manufacturing errors. We'd see large leaks if the manifold O-ring tore before or during the fire (propellant would be all over the place), which did not occur.

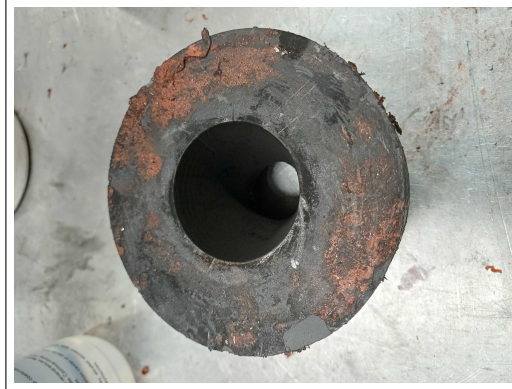
Figure 5: Nozzle.

The sealing method uses a thin layer of RTV between supersonic exhaust gases and the chamber walls, and there was damage to the RTV near the chamber walls. However, the temperature and pressure are a lot lower there, so it's less likely to burn through in that area.

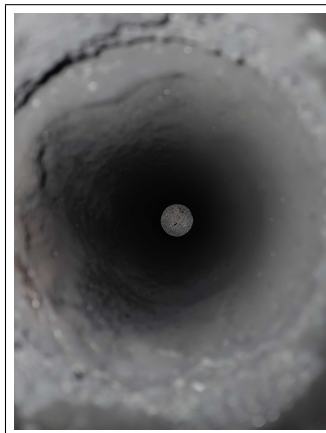
Figure 6: Combustion chamber.

Throat ablated about 90 thousandths of an inch, and highest ablation on the fuel grain is about 1.68 inches in diameter, leaving about 0.35 inches of thickness left to the grain. This is quite excessive, but with issues with tank pressure there's no guarantee that we will have this amount of buffer left with optimal chamber pressures. Post and pre CC performed nominally.

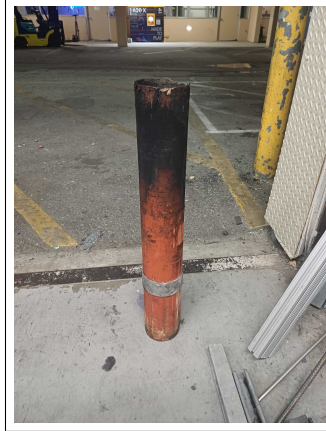
Figure 7: Liner.

The black is the result of a sealing issue, though it appears to be on the injector side, which doesn't really make sense since our O-rings sealed on the injector pretty well. The chamber inside showed no deformation. The seal broke at the nozzle to RR or the phenolic to nozzle. It is worth slathering RTV in that seal even more next time, since it may have been a miracle we didn't burn through.

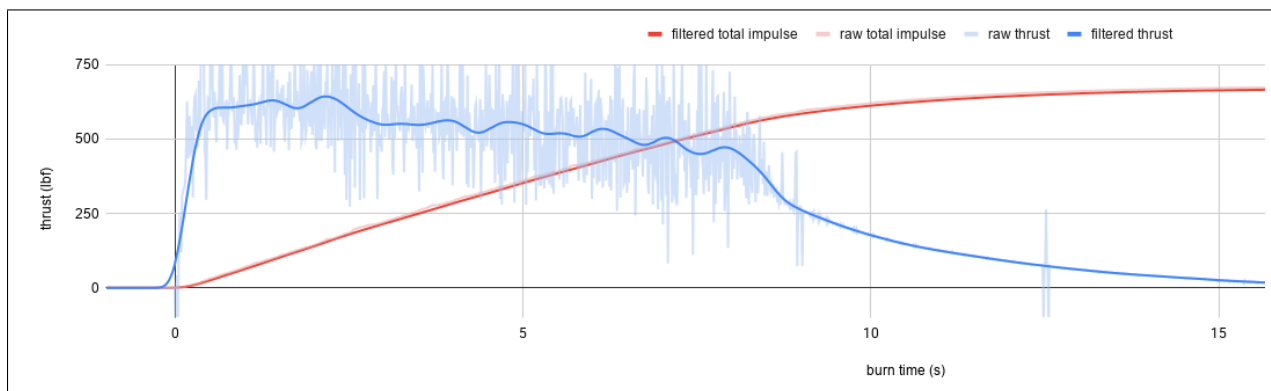
Figure 8: Thrust vs. Time

Data shows that the initial peak is not correlated with the tank pressure. There is an early thrust spike. This is an anomaly as these two should be proportional to each other and be on trend. Possible causes include a load cell issue correlated with a connection issue, where the connectors weren't connected properly and were incorrectly recording data. Another possible issue can be an overfilled oxidizer tank. If this were the case, it would explain why we have an early thrust spike and a longer total burn time.

As said, in the thrust curve, we have a lengthened burn time, which is another anomaly. This was likely caused by an overfilled oxidizer tank, as explained earlier. We could also have a lower empirical mass flow rate than the theoretical value, which would increase the burn time and extend the propellant's duration. Therefore, some of our feed losses or assumptions were likely off. Thrust and impulse are conservative, meaning that we only accounted for the dry mass and calculated our performance based on this, which is why impulse is lower than the actual value.

Before any future static fire, the load cell should be tested and calibrated at the test site after all wiring is connected. Electrical interference from the igniter is a known risk and shielding or rerouting the load cell cables away from igniter wiring should be standard practice going forward.
