**UCLA Rocket Project**  
Vehicle: Prometheus (Hybrid) | Cycle: 25-26

**Test Summary Report**  
**Static Fire Campaign #2**

**Document No.:** PROM-HFIRE-002-26101  
**Revision:** A  
**Release Date:** 2026-04-15

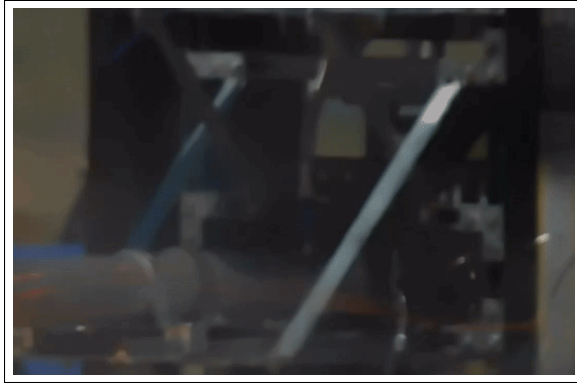
The load cell was not bolted to the structure's back plate, allowing the engine to lift within the clamps during the burn. The vertical displacement reduced the load cell readings, lessening the thrust measurement.

(a) Engine at rest, pre-ignition
